Manhole Inspection Summary

Manhole # S33KK1020MH

Insp Date: **4/28/07 9:12 AM**

Location Address: **4221 GREENWAY**

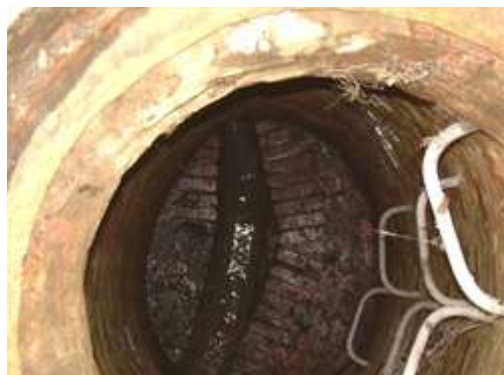
Top View

Bench debris.

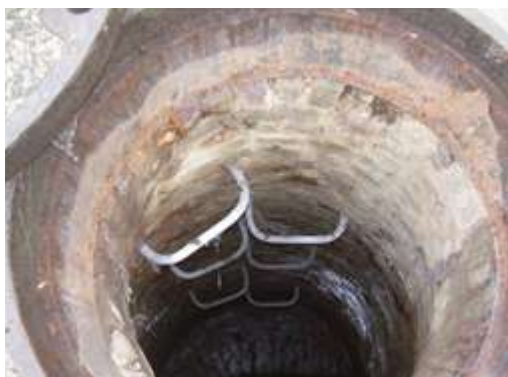
Defect

Frame leaks. Adjustment deterioration and infiltration. Corbel and Barrel infiltration.

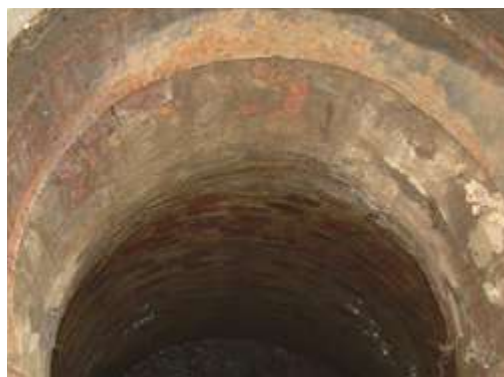
Defect

Frame leaks. Adjustment deterioration and infiltration. Corbel and Barrel infiltration - other side.

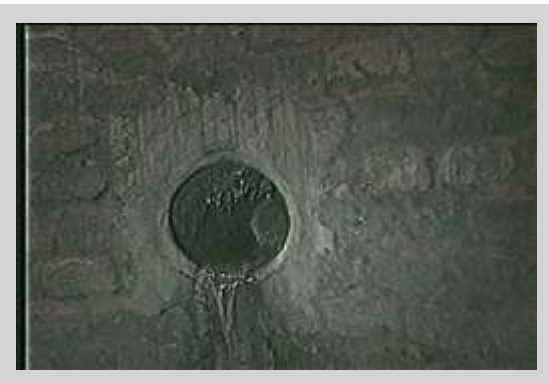
6 in. Circular Gravity Sewer Pipe In @ 7 O'Clock

Infiltration: **Evidence** Pipe Seal Cond: **Roots**

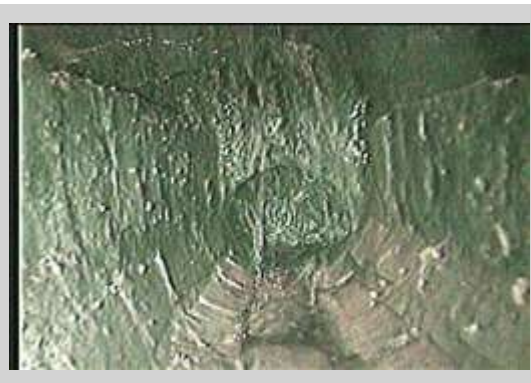
Drop In @ 7 O'Clock

Barrel root intrusion and infiltration.
